► Report on:

Fire Performance

Volume 1, Number 1

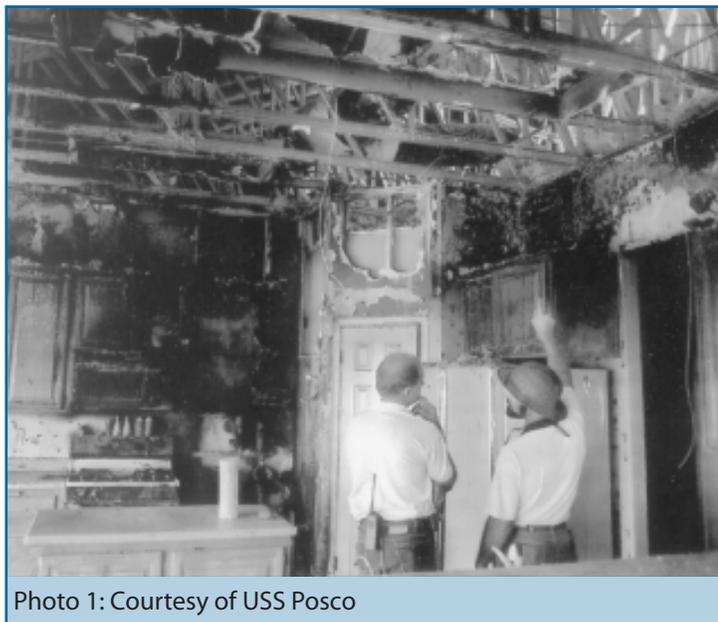
Photo 1: Courtesy of USS Posco

The fire caused \$75,000 in damages to the interior and personal property. In this steel framed home, the flames were contained to the kitchen with smoke damage elsewhere and no structural failure of the steel roof trusses or wall frames occurred. If this home was of typical combustible construction there would have been additional costs incurred to replace charred members and to chemically treat those charred members that were not replaced to seal in smoky odours.

According to firefighters the fire reached temperatures of 650 to 760°C (1200 - 1400°F) and yet no structural failure of the steel frame occurred. The firemen commented that if the structure was of traditional wood frame, the damages would have been more extensive.

An analysis was performed on the steel truss cord and wall studs in the area most affected by the fire. Physical testing showed that

the mechanical properties of the members still met the specifications for structural steel studs. The zinc coating on the steel remained intact and in some places there was evidence of alloying with the steel substrate to produce galvaneal, a product commonly used in manufacturing automotive body panels. As a result of this analysis, none of the framing members needed to be replaced.

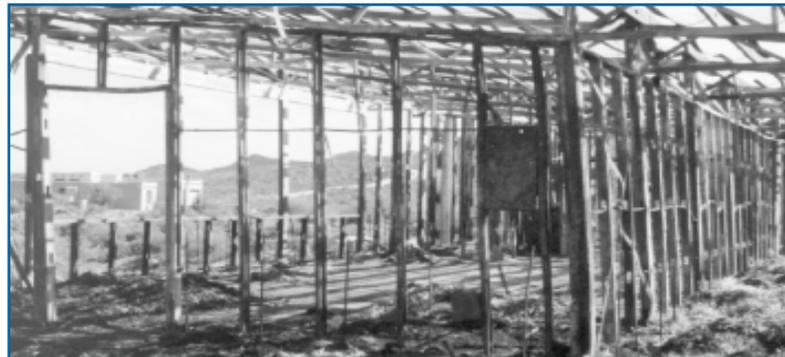
Since this building was not yet finished the fire spread quickly. When Tucson fire response teams arrived, the structure was fully engulfed and a decision was made to let the fire burn itself out. The fire reached temperatures of 650°C (1200°F) which was hot enough to severely crack the concrete floor slab. When the smoke cleared the steel framing was still standing. Doug Emans, assistant fire chief at the scene was surprised. He said "a similar wood structure would have collapsed". Another firefighter commented that wood would have been "toast". In fact 2" x 6" lumber used to frame around some of the openings was just that. With the framing still standing it greatly reduced the fireman's task of checking the debris to ensure all hot embers were out.

The insurance claims adjuster was also impressed. In all of his experiences of inspecting the aftermath of fires he couldn't believe the roof trusses and walls were still standing after all the sheathing had burned off.

Photo 2: "Steel framing still standing after the fire."
